# Remediation Strategies and Water Quality of Estuarine Impoundments

Jens Lamping

A thesis submitted in partial fulfilment of the requirements of the Council of the University  
of Durham for the Degree of Doctor of Philosophy (PhD)

### **Remediation Strategies and Water Quality of Estuarine Impoundments**

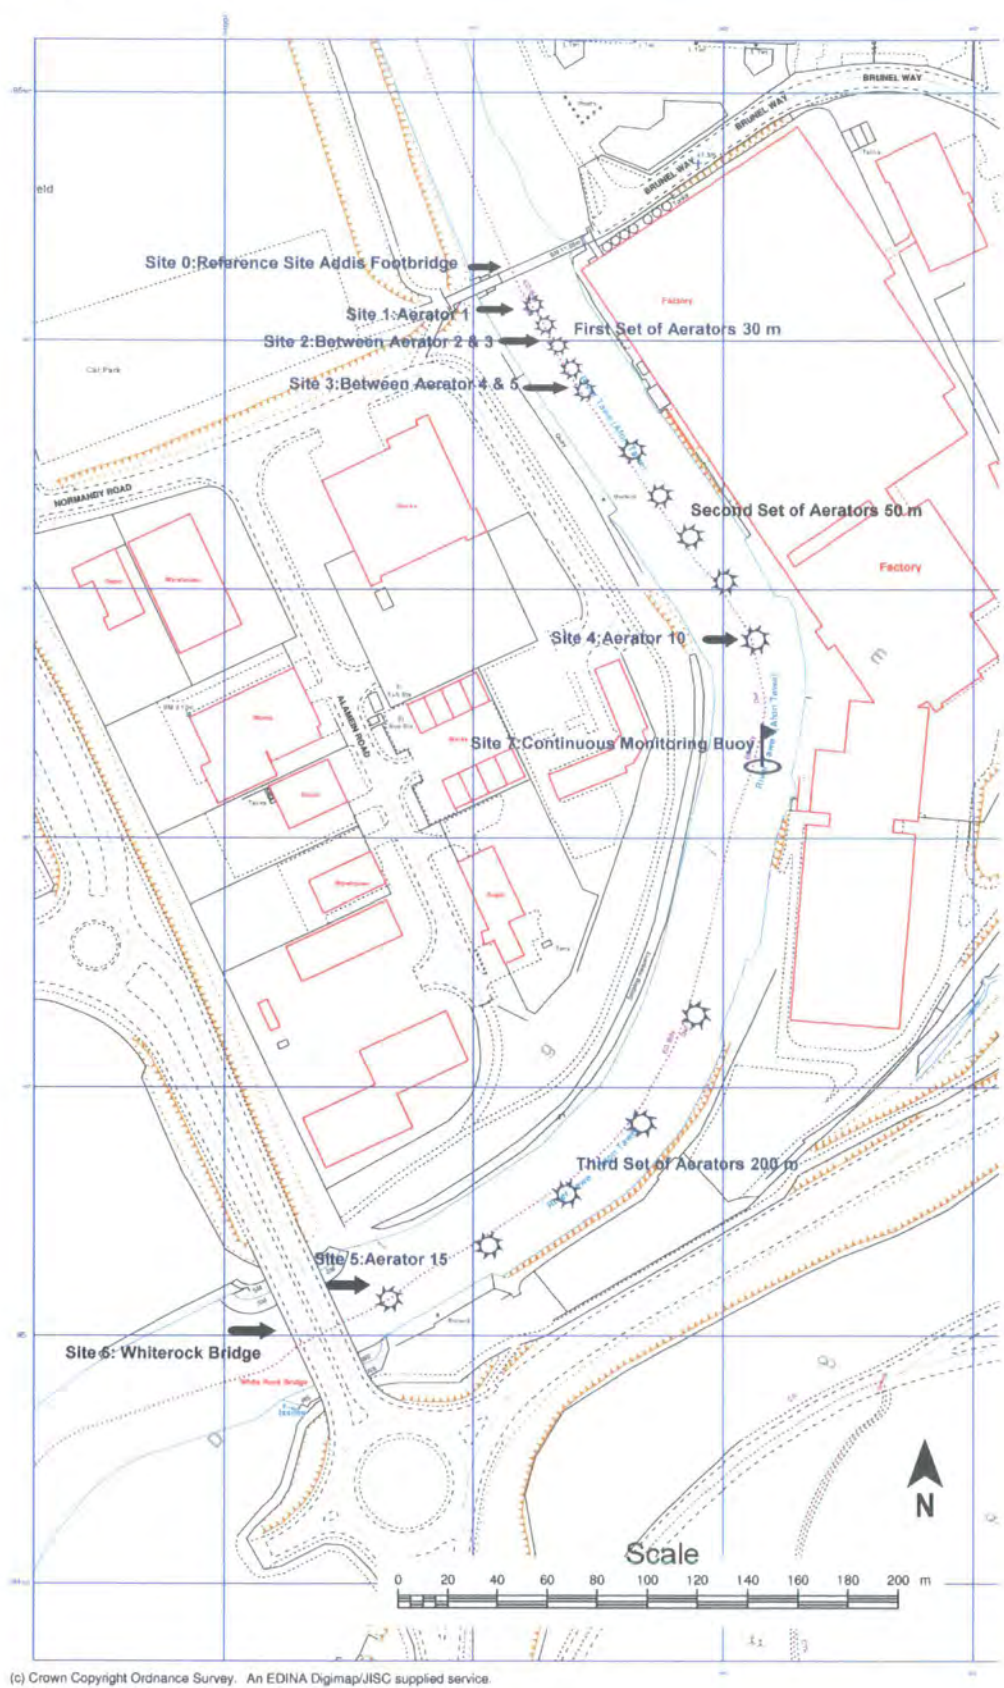
Figure 2-24 Aeration trial equipment overview map

With the joint water quality monitoring program of SCC and the EA Wales ongoing, the aeration trials started in August 1998, with 15 diffuser tubes (70 mm OD, 0.5 m length- Figure 2-23) deployed in a 280 m river section between Addis Footbridge and Whiterock Bridge (Figure 2-24). Three sets of five tubes were placed in the deep channel, unequally spaced over distances of 30 m, 50 m and 200 m, respectively. They were supplied by a 16 mm ID self-sinking airline with 3 shore based compressors (Reitsche, 3 phase noise reduced vane type, 1.8 kW) housed in cabinets. In addition, a 'Banana Blade' mixer (ITT Flygt, 1.4 m diameter, app. 36 rpm), housed in a stainless steel frame, was installed adjacent to the fish-pass at a depth of 2 m from the surface. Earlier tests at greater depths indicated that better efficiencies were achieved by lifting rather than pushing the stagnant saltwater over the pass.

The diffusers were switched on at midday on the 25<sup>th</sup> August and left running until the 8<sup>th</sup> September. Vertical profiles were obtained once a day on 25<sup>th</sup>, 26<sup>th</sup>, 27<sup>th</sup>, 28<sup>th</sup>, 30<sup>th</sup> August and 2<sup>nd</sup> September. Profiles of salinity, temperature and dissolved oxygen were taken in 0.5 m depth intervals at 6 agreed sites (Figure 2-24) at an appropriate distance from the actual diffuser cone. The oxygen profile of the 30<sup>th</sup> August had to be rejected during the analysis, due to poor quality of the readings. The mixer unit was started on the 27<sup>th</sup> August and left running until the 7<sup>th</sup> September. In addition to the sampling, two bed-mounted YSI water quality probes were deployed 50 m upstream of the last set of diffusers (Site 7-Figure 2-24) at a depth of 1 m and 3 m from the surface. These sondes continuously recorded salinity,

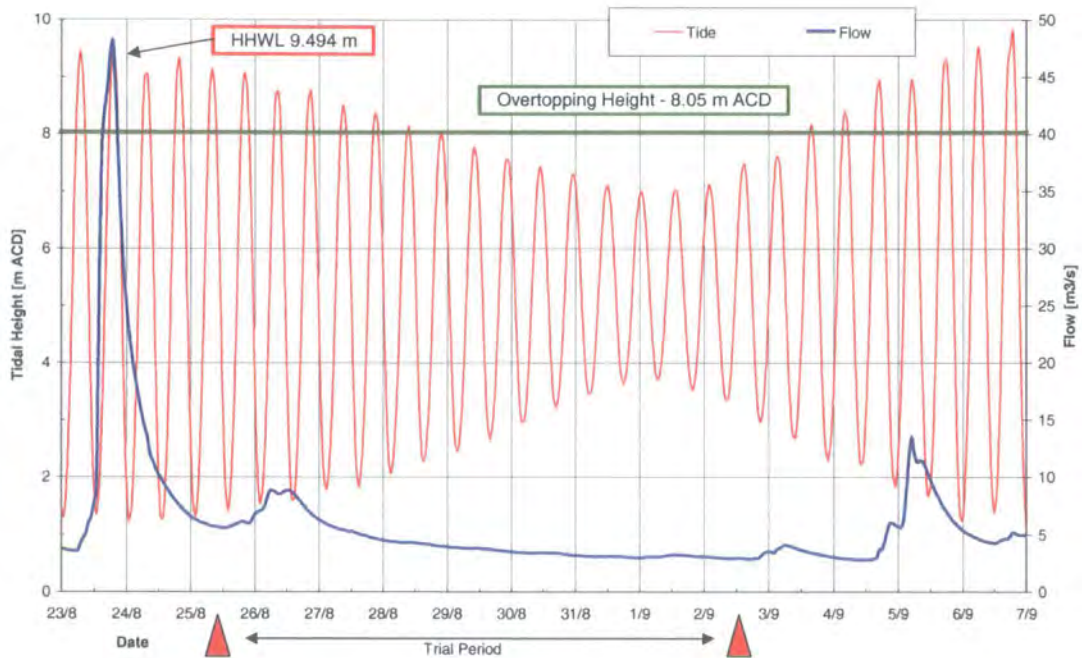
Figure 2-25 Tidal regime and freshwater flow during the aeration trial period 1998

Predicted tidal heights for Swansea led to the assumption, that the trial period would not be accompanied by overtopping tides. However, the observed tide levels from Mumbles gauging station revealed that intrusion of seawater was still apparent on the next 5 tides after the trial started (Figure 2-25). The extent, to which this affected the trial site 3 km upstream is discussed later.

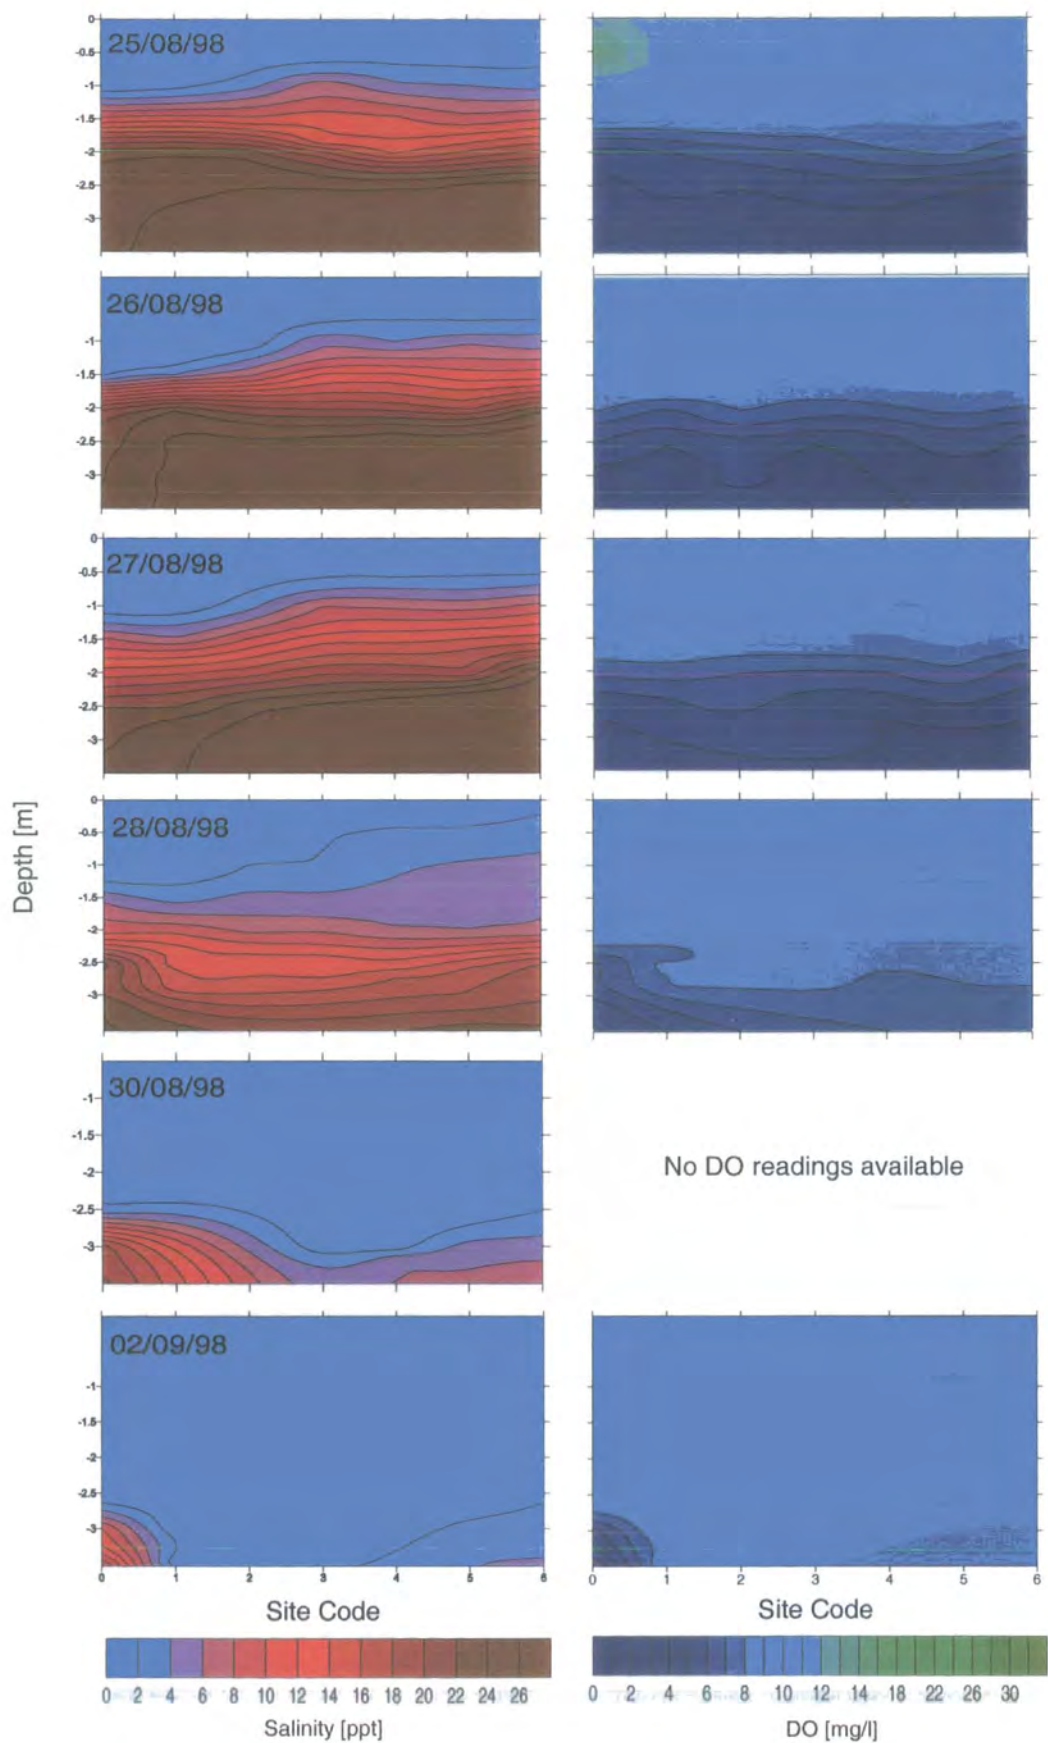
Figure 2-26 Longitudinal salinity and DO contours during aeration trial period 1998

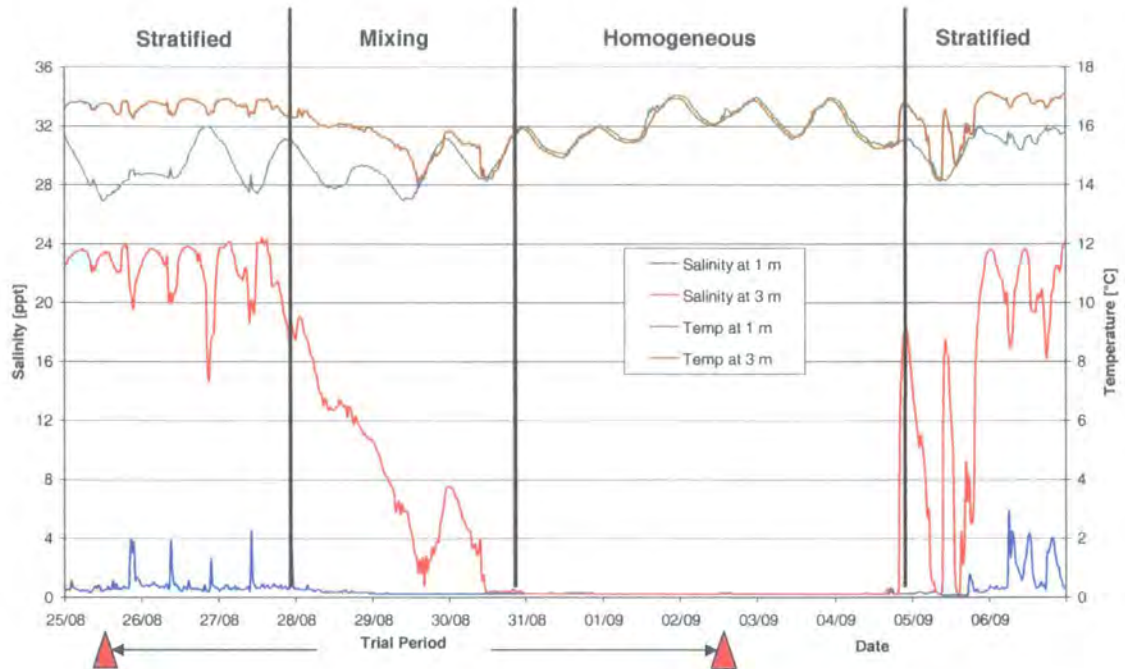
Figure 2-27 Continuous water quality data during aeration trial period 1998

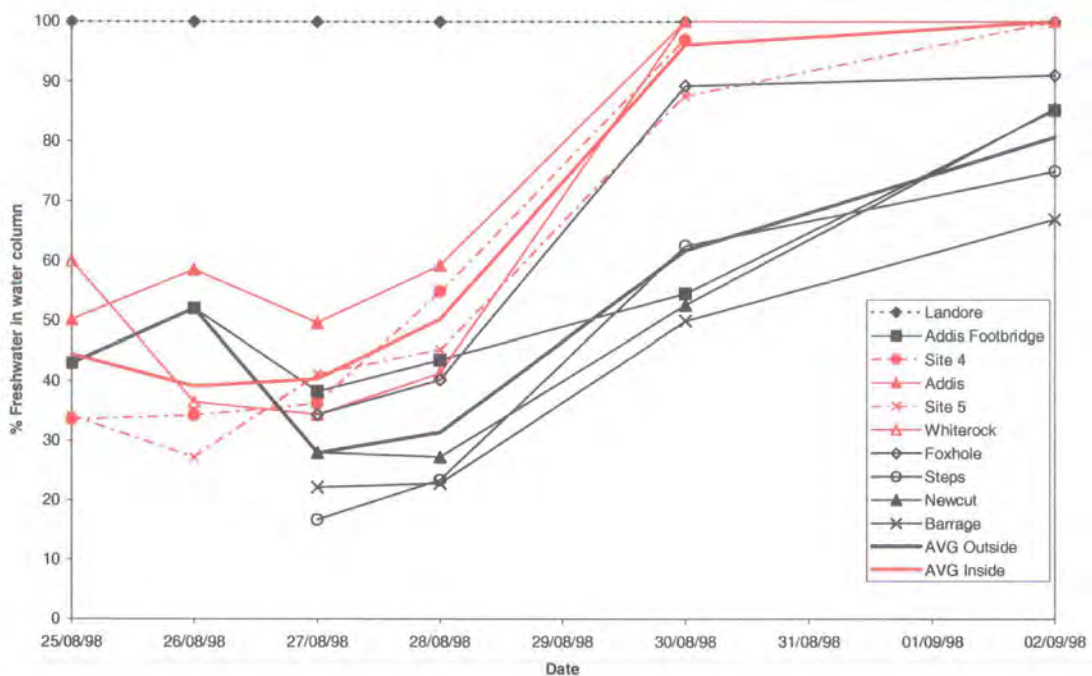
**Figure 2-28 Freshwater percentage in the water column of aerator and reference sites during the aeration trial period 1998**

The percentage of freshwater (defined as <5 ppt Salinity) in the measured water column of each site over the trial period is compared in Figure 2-28. Landore, as the furthest upstream site, was unaffected by tidal intrusion or aerator activity and remains at 100% freshwater level, while other profiles consisted of only 17% freshwater (Steps, 27/08/98) before mixing or erosion of saline layers was observed. Assuming that the upstream reference site Addis Footbridge and the downstream sites Foxhole, Steps and Barrage define those sites unaffected by the aerators, an average 53% reduction of saltwater was triggered by shear forces introduced through freshwater inflow, which left those sites at an average of 20%

described by both data sets. While the contours of the sample data provide a picture of the geometry of isohalines, the continuous record supplies a matching series of salinity and temperature fluxes for the surface and deep water layer. The most interesting feature of the trial period is the actual break up of stratification at the monitoring sites 1-6 during the course of the 4<sup>th</sup> trial day (28/08/98), while the reference site 0 (Addis Footbridge), 200 m upstream of the first set of aerators, remains stratified. Since the downstream reference site 6 is comparably shallow (2.0 – 2.5 m) and in 50 m proximity to the last aerator set, other downstream sites had to be compared to the aerated river section. The regular monitoring programme provided additional data for the standard sites Landore, Foxhole, Steps and Barrage (Figure 2-11) from 27/08/98 onwards, which, in conjunction with the trial section data, delineates the impact of the diffusers.

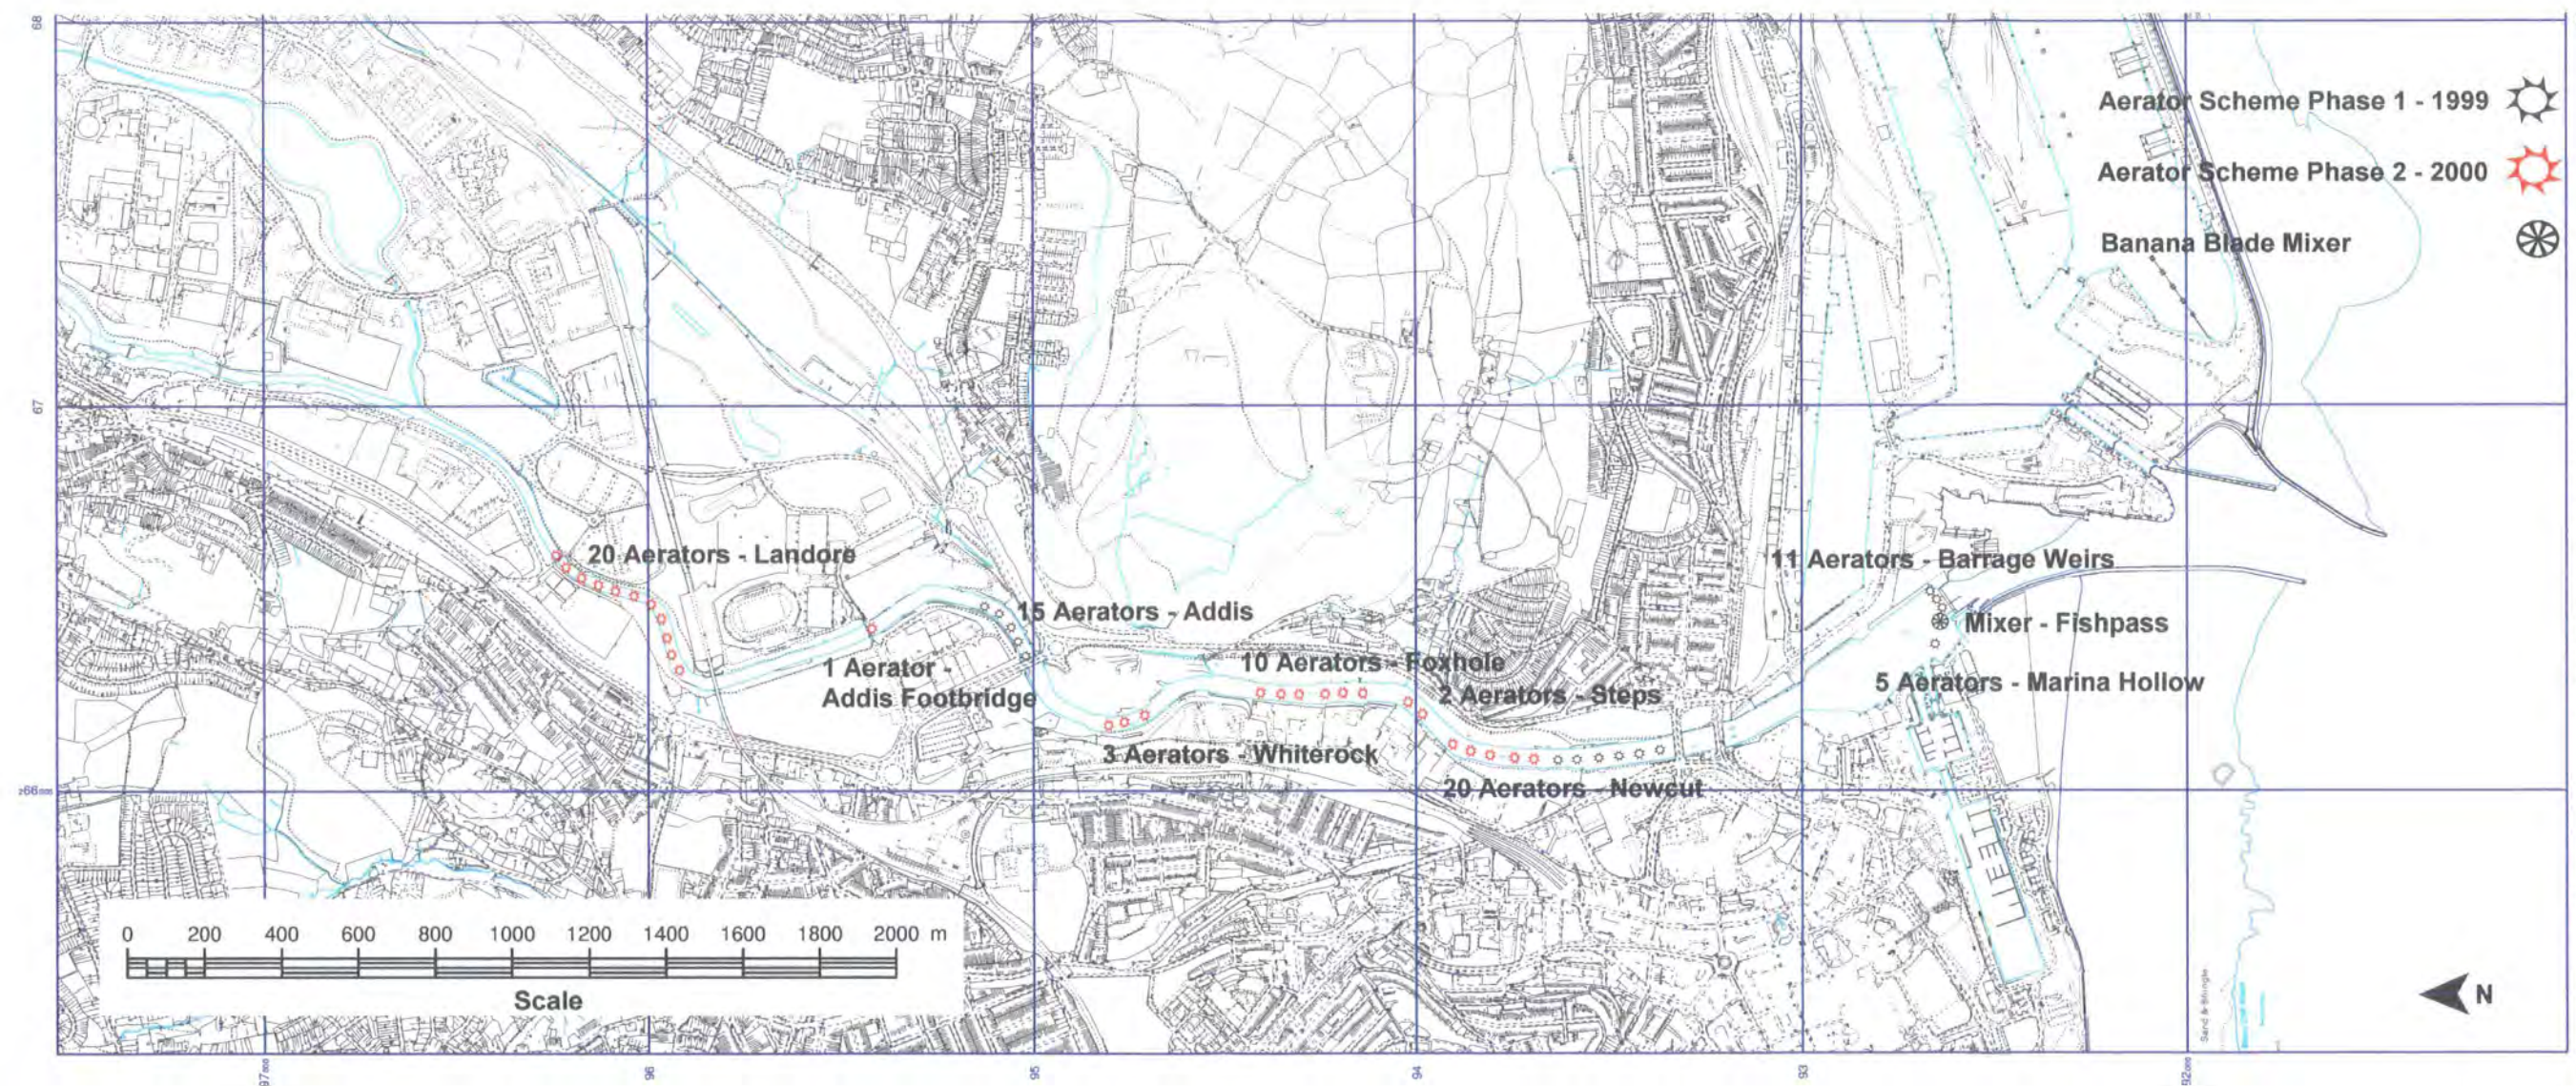
Figure 2-29 River Tawe aeration scheme 1999-2000 (overview)

Following the successful completion of the aeration trials, CCS awarded EAC with the contract of supplying a full mixing/aeration system, which was installed by the EAC in two phases during the summer of 1999 and 2000. For the amount, schedule and location of equipment installed please refer to Figure 2-29. Phase 1 of the aeration scheme consisted of 44 diffusers, with 11 installed immediately upstream of the barrage (3 at the primary weir, 8 at the secondary weir), 5 in a hollow next to the marina, 13 at the Newcut site and 15 remaining installed after the trials between the sites Whiterock and Addis (Figure 2-29). Phase 2 involved an additional 43 of diffusers with an extra 7 at the Newcut site, 2 at the Steps site, 10 at the Foxhole site, 3 downstream of the Whiterock site, 1 at the Addis site and 20 installed near the furthest upstream site, Landore. To assess the effectiveness of the equipment in preventing low DO conditions, the water quality monitoring programme of the EA Wales and CCS was continued at their agreed sites during 1999-2002. The observed data sets were made available to this study, for an evaluation of the impact the two aeration stages had on the DO distribution within the impoundment under different conditions. Monitoring during the aeration period only covers flow conditions below  $17 \text{ m}^3/\text{s}$ , due to safety issues. However, stratification is less likely to occur at higher flows and can therefore be excluded from the assessment analysis.

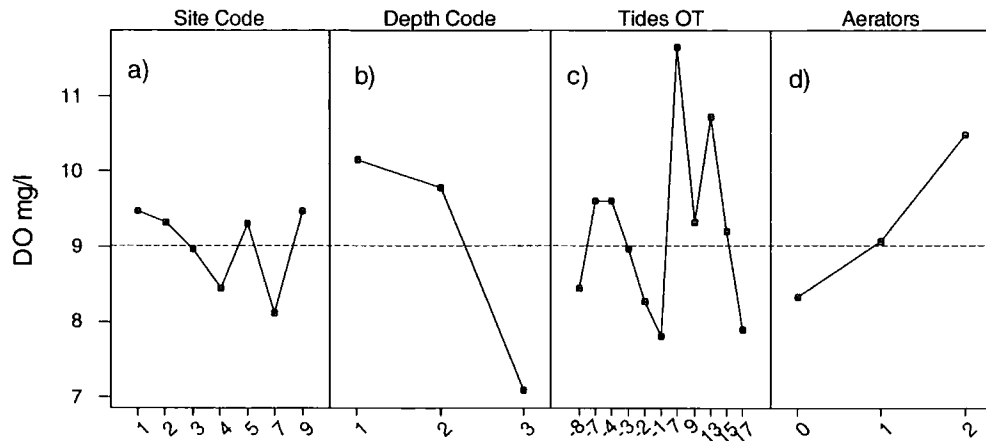
**Figure 2-30 Main effects plot for DO mean levels in the Tawe, dotted line indicates overall mean**

It is illustrated (Figure 2-30-a) that DO decreases with distance upstream, with exception of the shallower sites 5 (Whiterock) and 9 (Landore). The large influence of site depth is documented by the gap between DO means of epilimnial and hypolimnial layer (Figure 2-30-b). Significant variation is also indicated for the DO of different stages within the tidal cycle (Figure 2-30-c). During overtopping periods the DO is generally higher, with decreasing levels towards the end of the regime. For non-overtopping conditions, DO levels are lowest directly after the regime changed, while levels improve with prolonged non-overtopping. Levels at maximum periods (-8), however, were observed to drop below the overall mean again. The different treatment levels of aerators (Figure 2-30-d) induced a nearly linear increase in DO levels. While conditions were at 8.3 mg/l pre-aeration, the first phase of 44 aerators lifted the mean to 9.1 mg/l and the second phase of 87 aerators resulted in a shift to 10.53 mg/l. Although the main effects plot provides valuable information on factor specific impacts, it is equally important to discover interactions between the factors, e.g., sites where phase 2 aerators improved conditions most. Therefore, an interaction plot matrix (Figure 2-31) was created, in which the means for DO levels in relation to the factors site code, depth and aerators are given. Plot b) and d) represent the DO means for a two factor matrix of site code and depth code, while the effect of the third factor, aerators, is removed. In this, a pair-wise comparison of factors without the influence of the third factor is possible when analysing the graphs. Subsequently, the plots f) and h) describe the two factor matrix depth code and aerator phase, while plots c) and g) show the interaction between aerators and site code. In terms of expressiveness, it would have been sufficient to display only one of the pair-wise interaction plots, but the display of a full interaction plot matrix sometimes allows for better discrimination of significant factors.

The largest effect amongst the factors is that of the tidal regime (Tide OT), which explained 22% ( $\omega^2 = 0.22$ ) of the variation in DO levels. The site factors, depth and site code, together described 10% ( $\omega^2 = 0.10$ ) of the total variance and improved the model slightly when included as an interaction (Depth Code \*Site Code). Regarding the overall DO mean, the aerator phases provided a surprisingly small impact of 5 %, but the separate impact of each factor has to be considered as well. This is provided by in the main effects plot (Figure 2-30), which illustrates the variance of DO levels due to each factor included.

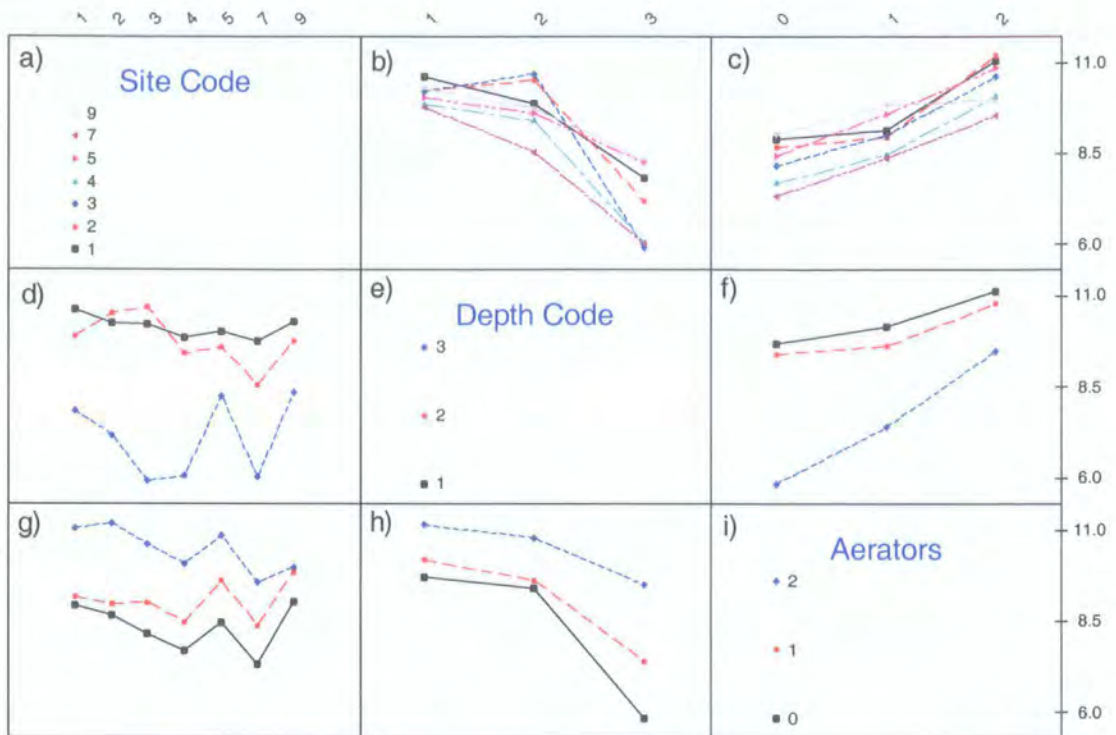
**Figure 2-31** Interaction plot for DO mean levels in the Tawe, plot a), e) and i) indicate symbol definition for different factor levels

Starting with plot d), it can be observed that the DO means for the near bed layers (Depth Code 3) are higher at sites closer to the barrage (Site Code 1 and 2) and for the shallow sites (Site Code 5 and 9), whereas low DO means are detected at the deeper upstream sites (Site Code 3,4 and 7). The large gap in DO levels between the hypolimnion (Depth Code 3) and the mid and surface layers (Depth Code 1 and 2) suggests stratified conditions throughout the profile. The DO at mid depth (Depth Code 2) distinguishes further from the surface water with increased distance from the barrage (Site Code 4-9), indicating enhanced stratification, while the downstream sites (Site Code 2 and 3) show reversed DO levels for mid and surface layers, suggesting mixed conditions for these layers.

The influence of the different aerator phases on the DO means at the three different depths (Figure 2-31 – f and h) suggests that their application provided an increase in DO means for all depths, with a maximum effect in the hypolimnetic layers (Depth Code 3). The first phase of aerators led to a 1.0 mg/l increase of the depth DO means. The mid depth mean levels were not affected by the introduction of the first phase (Aerators 1) of remedial measures, while the surface levels only showed a slight improvement with an increase of 0.3 mg/l DO. The second phase of aerators (Aerators 2), however, provided

Considering the impact of distance and site depth on DO means, it is demonstrated in plot c) and g) that the aeration effect becomes more pronounced with distance upstream during aerator phase 1. Sites closer to the barrage (Site Code 1 and 2) only showed a slight improvement of DO conditions while the upstream sites (Site Code 3-9) indicated DO increases of about 1.0 mg/l as a result of the first 44 aerators installed. The addition of aerators in phase 2 provided a major jump in DO means throughout the longitudinal profile with average increase of 1.0-2.0 mg/l, compared to aerator phase 1. The only exception is the furthest upstream site 9, where DO levels were generally high, as indicated in plot d) and g).

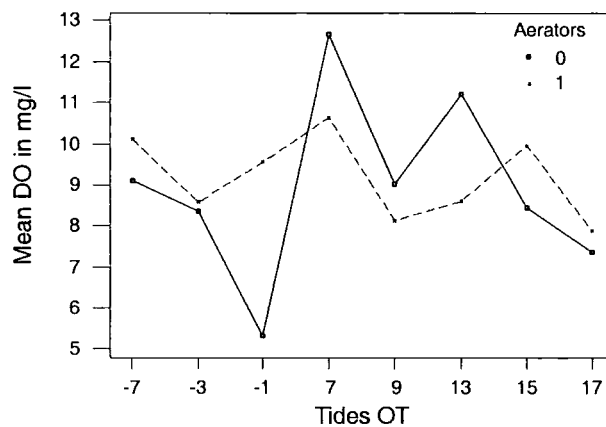
**Figure 2-32 Interaction plot of DO means for tidal regime and aeration phase 0 and 1**

The DO means in Figure 2-32 demonstrate that aeration phase 1 led to an increase of levels only during non-overtopping periods and towards the end of the overtopping cycle (15-17 Tides OT). The impact of phase 2 in Figure 2-33 is noticeable for all tidal conditions although the range of conditions here is smaller compared to Figure 2-32. Nevertheless, both aeration phases suggest a maximum effect on the DO means for the first non-overtopping tide (-1 Tides OT) and a minimum impact after long influx periods (13 Tides OT).

Although the tidal regime (Tides OT) was mentioned as a factor to be included, the model was not able to calculate the interaction effect for three phases of aeration. Nevertheless, it was possible to include the tidal regime for modelling two aeration levels, e.g., 0 and 1 or 0 and 2, and the interaction plots for those models are given in Figure 2-32 and Figure 2-33.

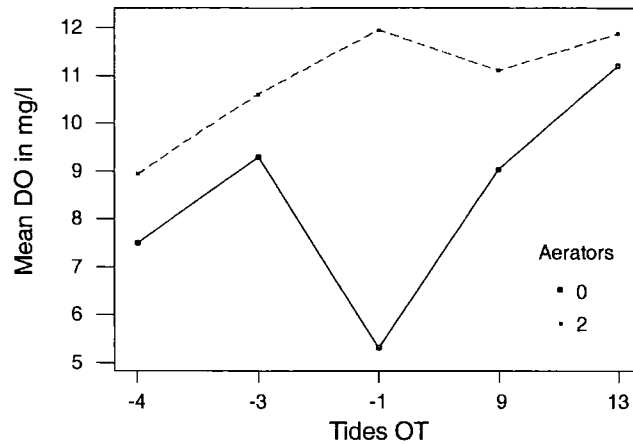
**Figure 2-33 Interaction plot of DO means for tidal regime and aeration phase 0 and 2**

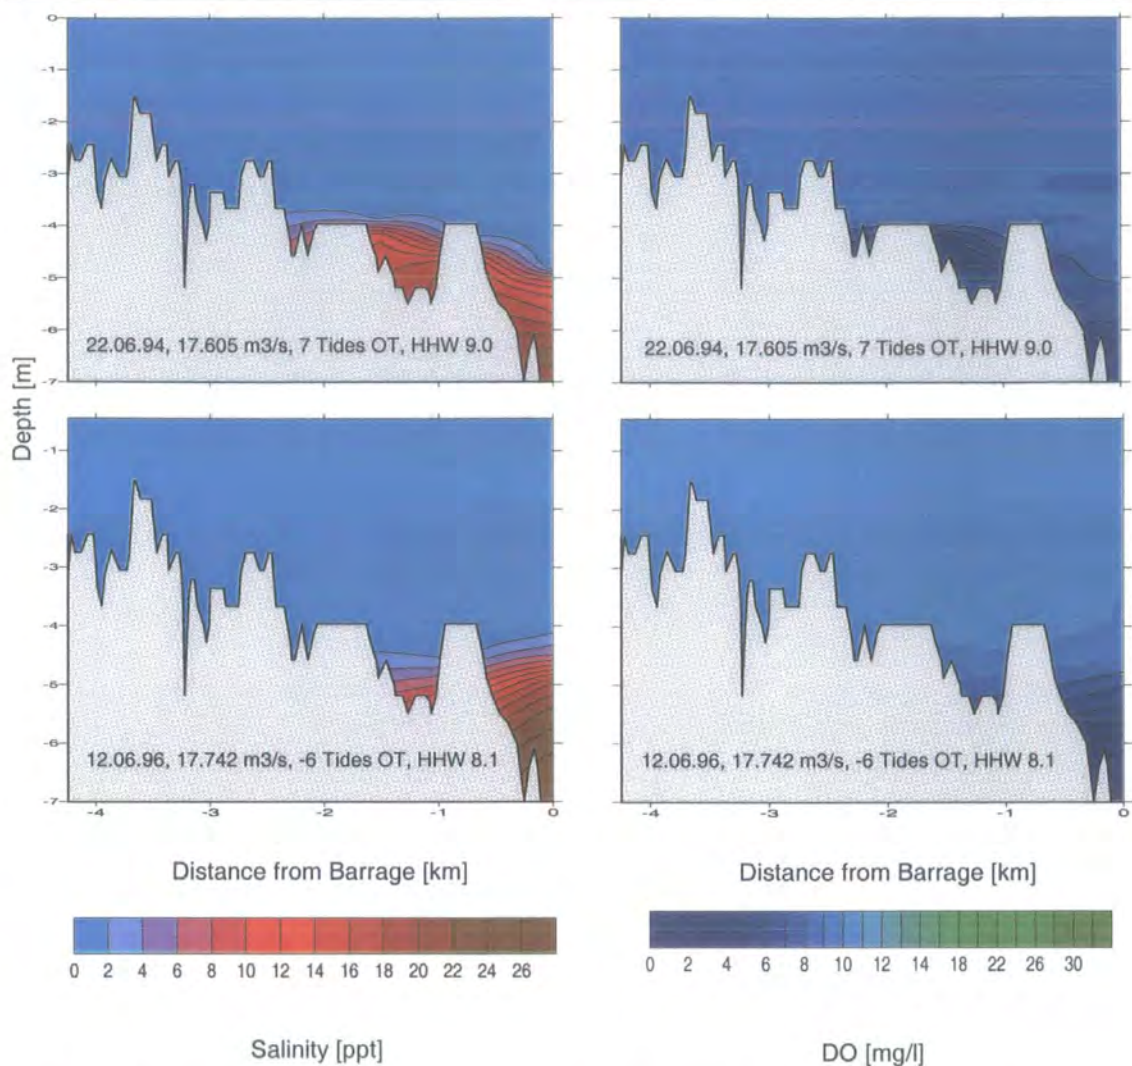
Figure 2-34 Longitudinal salinity and DO contours for high flows during pre-aeration period

The isohalines of 22/06/94 (Figure 2-34) show that, although seven tides overtopped the barrage at 9.0 m ACD, saline waters were restricted to deeper sections within a 2 km distance of the barrage, due to the high river discharge. The top 4 m of the profile is fresh, and only slightly reduced DO conditions were recorded at depths within the lower impoundment. The conditions look similar during non-overtopping periods of 12/06/96 (Figure 2-34) with stagnant saline waters and low oxygen levels only persisting in the vicinity of the barrage, due to the dominance of high freshwater flows.

vicinity of the barrage (Figure 2-34). In addition to the impact on the breakdown of stratification during non-overtopping periods, the amount of freshwater also restricts the up-estuary marine water intrusion during overtopping periods, as seen in Figure 2-20 and Figure 2-21. Dependent on the flow conditions during the highest spring tide levels, certain aerator sections were not required and performed less effectively compared to deeper sites further downstream. Site number 9 is an example which showed only minor improvements of DO conditions although 20 aerators (Figure 2-29) were installed there. The area around this site is generally freshwater dominated and low DO conditions rarely occur as a result of salinity stratification. Furthermore, it was seen from the observational data that the equipment was successful in preventing the build up of a pronounced halocline within the impoundment. Whereas low flow, non-overtopping periods featured sharp salinity gradients at depths around 1.0-2.0 m (09.09.96 and 25.06.96-Figure 2-35) pre-aeration, this was not apparent during similar conditions for aeration phase 1 and 2. Subsequently, algal blooms that tend to be on top of the halocline, due to reduced velocities in that layer (Figure 2-35), disappeared with the introduction of the aeration scheme and are now restricted to sites where less mixing occurs.

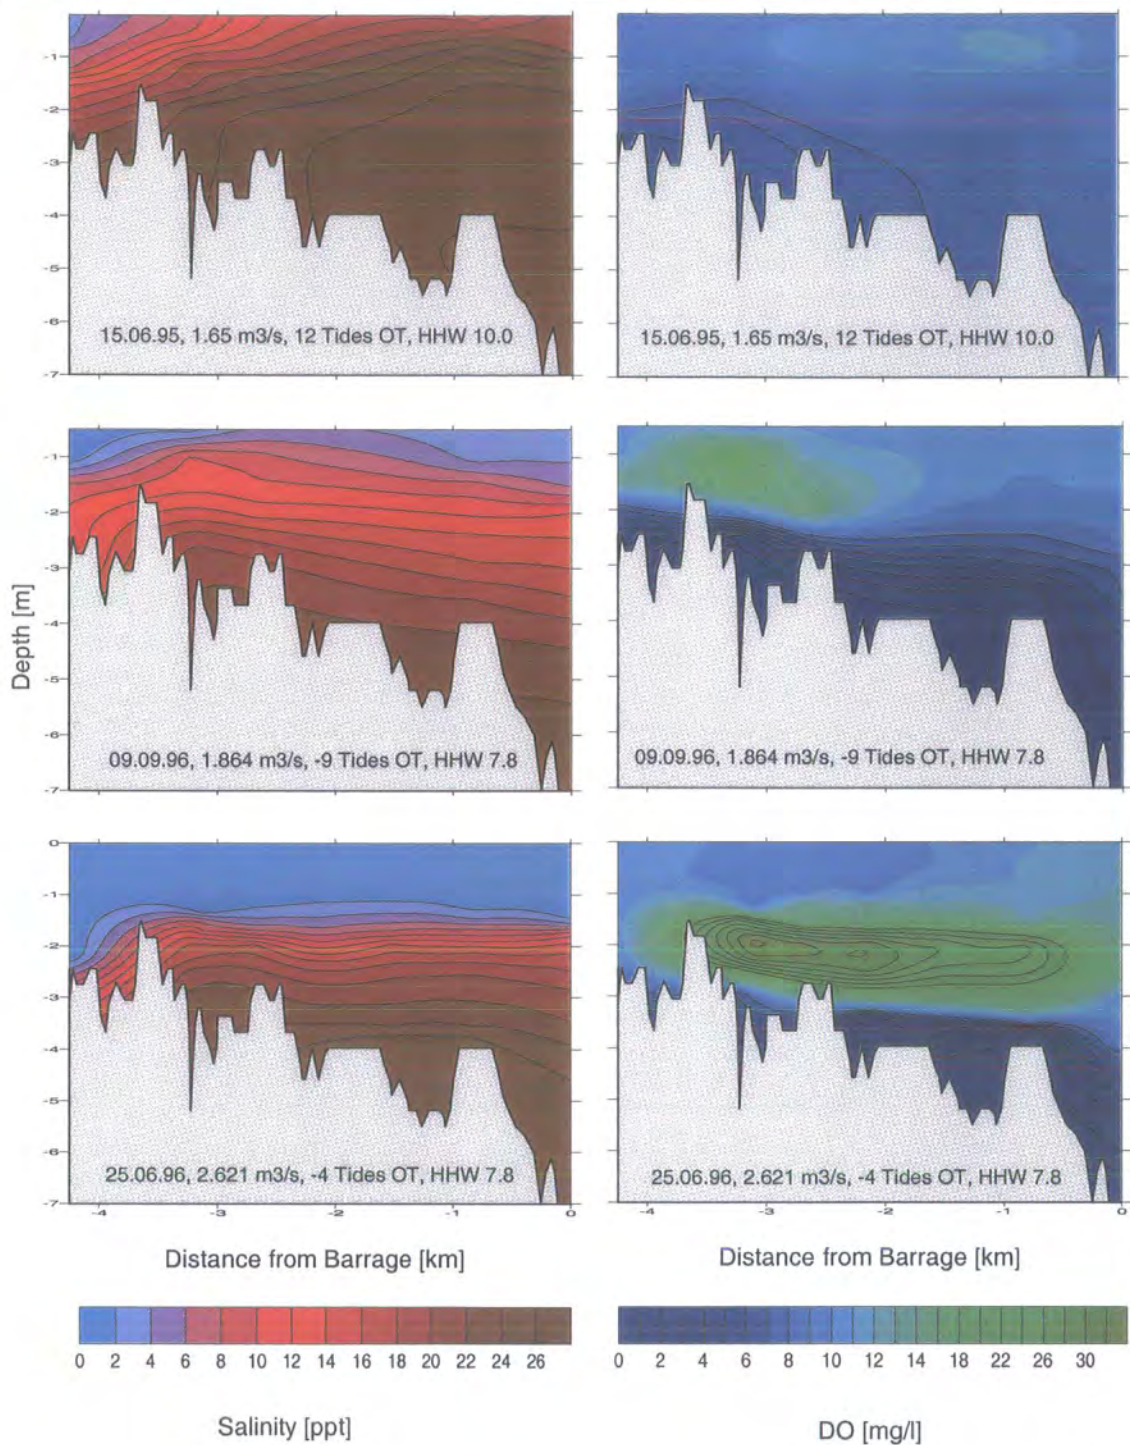
Figure 2-35 Longitudinal salinity and DO contours for low flows during pre-aeration period

The salinity and DO contours for low river discharges (Figure 2-35) present a completely different picture. Saline intrusion with levels >14 ppt dominate the profile on 15/06/95, after twelve tides overtopped the barrage at a maximum tide level of 10.0 m ACD. The extensive marine water intrusion provided saturated DO conditions for most of the impoundment, leaving only the upstream end (Landore, -4.25 km) slightly reduced. In contrast, stratified conditions are apparent after non-overtopping periods, as shown for 09/09/96 and 25/06/96 (Figure 2-35). Both profiles feature a stagnant saline wedge

confined by a top layer of freshwater. The slight difference in freshwater flow resulted in a thicker freshwater layer on 25/06/96, narrowing the sharp salinity gradient to an approximate halocline depth of 2.0 m. The DO levels are reduced in the deeper sections, although adjacent to hypoxic conditions across the halocline. The oxygen profile on 25/06/96 presents a three layered system throughout the complete transect, with fresh water at the surface, hypoxic conditions at 2.00 m depth and a DO depleted layer near the river bed.

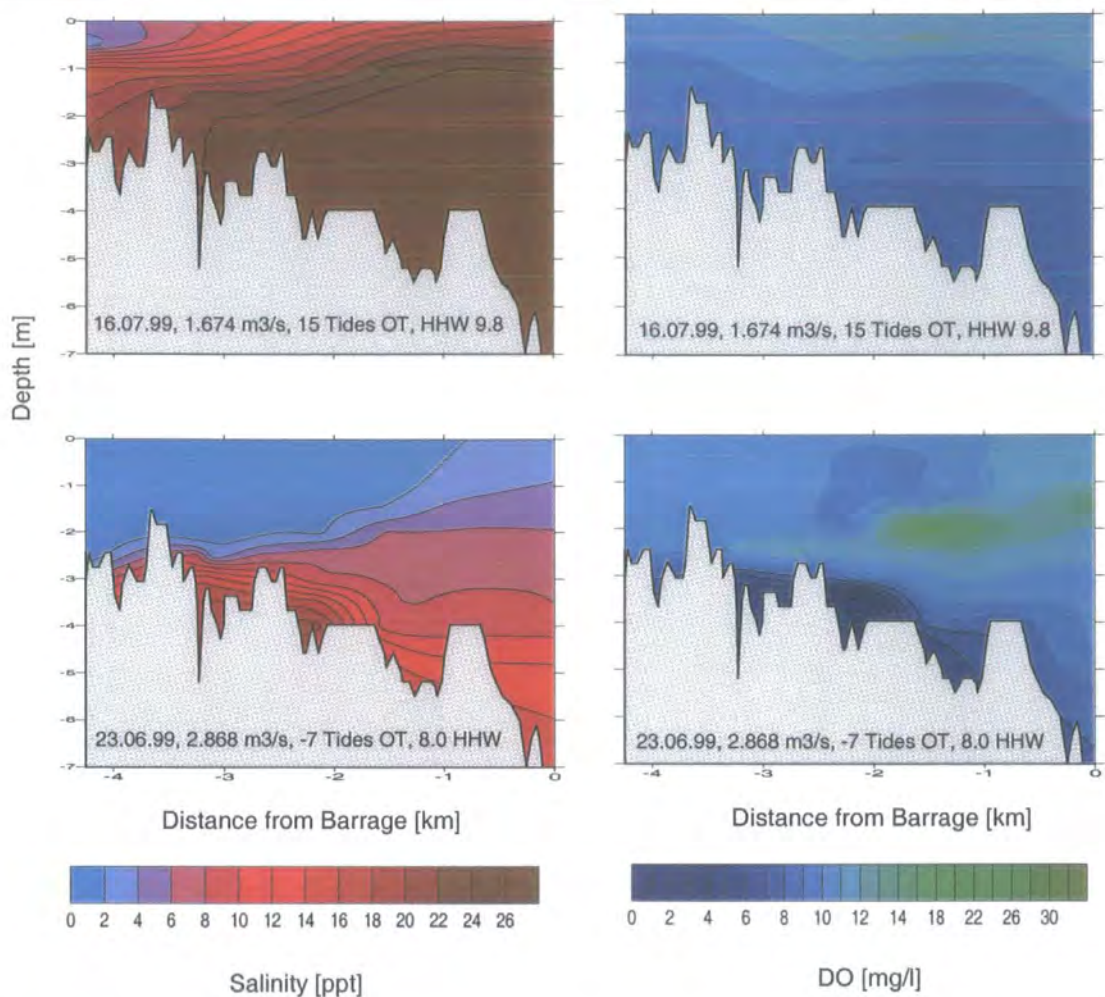
Since it was discovered that stratification is more likely to occur during low flow summer periods the following plots in Figure 2-36 and Figure 2-37 for the aeration phases focus on these conditions. Typical salinity and DO patterns are given for the first phase of aeration (with 28 units deployed within 1.2 km distance of Barrage and another 15 installed at Addis, 3.2 km upstream) in Figure 2-36. The contours of 16/07/99 indicate extensive salt intrusion after 15 tides overtopped at maximum level of 9.8 m ACD. Due to the low freshwater supply and the additional mixing of the aerators, a distinctive freshwater layer can only be identified at the furthest upstream end, leaving most of the profile at salinities >18 ppt. The DO levels also show a relatively homogenous distribution throughout the profile, as a result of fresh seawater ingress and introduced mixing. The contours of 23/06/99 during similar flow conditions, but after seven non-overtopping tides, present a different picture. The profile is stratified, with saline waters trapped in the deep hollows of the upstream sites (Foxhole 2.1 km, Addis 3.2 km), while the sites further downstream show a lower salinity at depth. This is also reflected in the DO profile, which indicates almost anoxic conditions for the stagnant upstream sections and reduced DO levels at downstream depths.

Figure 2-36 Longitudinal salinity and DO contours for aeration period phase 1 during low flows

The profile of 18/04/02 (Figure 2-37) after 17 tides overtopped at a HHW of 9.1 m ACD demonstrates that the saline wedge had moved well into the estuary, but also indicates a lower salinity for the metalimnetic layers (1-3 m Depth) when compared to the similar conditions during phase 1 (16/07/99-Figure 2-36). The DO profile shows well-mixed conditions with a slight decrease of levels at the upstream end (Landore, 4.25 km). The profile of 18/09/02 (Figure 2-37), during very low river discharges and after eight non-overtopping tides, does not appear to be as critically stratified as the comparable profile of the 23/06/99 (Figure 2-36) in aeration phase 1. Depth salinity ranges from 8-12 ppt, and arrested pockets of salt water cannot be observed in the rather homogenous profile. However, reduced DO conditions were recorded for the deeper layers with lowest concentrations at the upstream end.

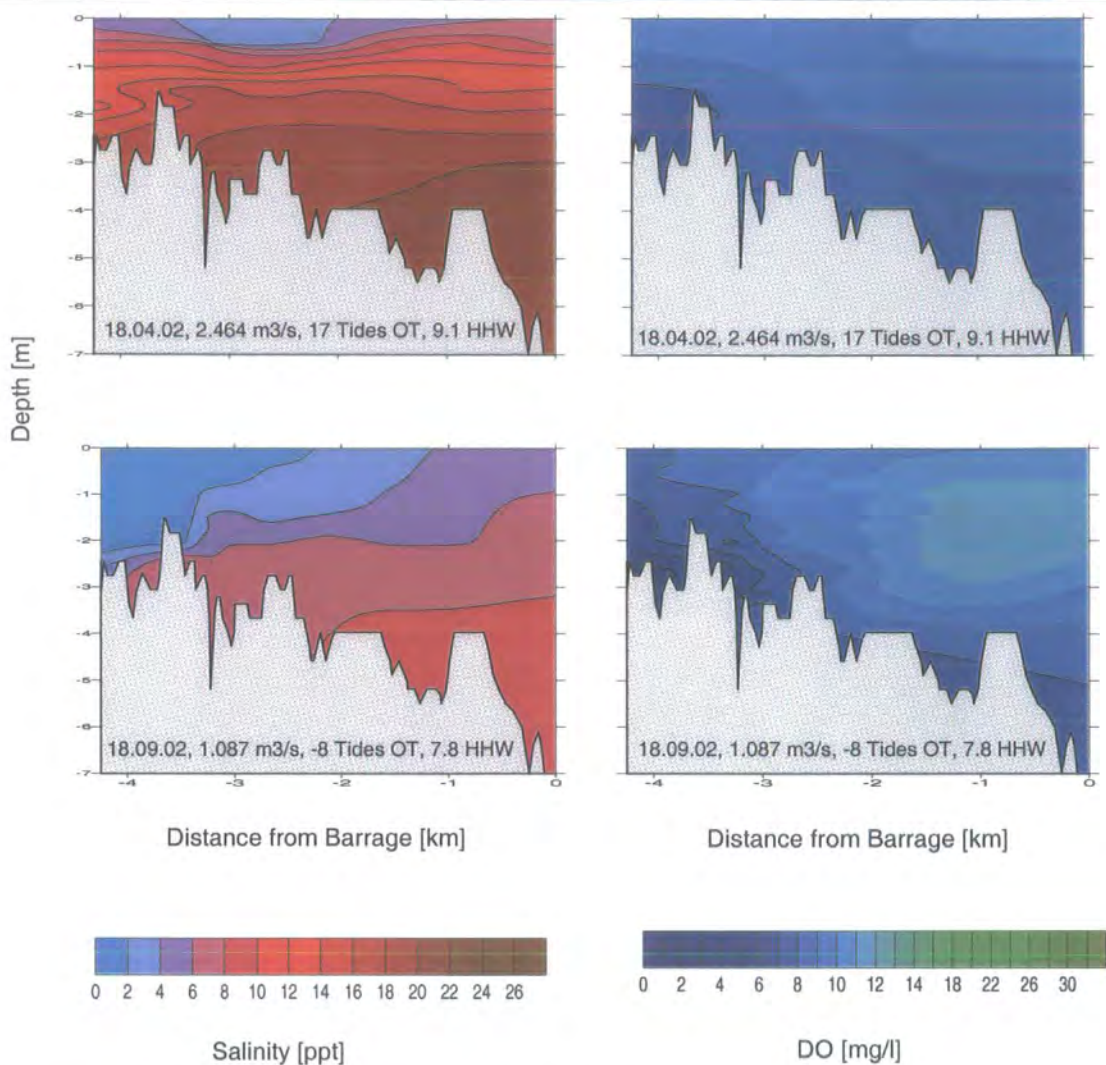
The contours for aeration phase 2 (Figure 2-37) indicate that, for periods of overtopping, similar salinity contours can be observed when compared to the low flow overtopping profile during aeration phase 1.

**Figure 2-37 Longitudinal salinity and DO contours for aeration period phase 2 during low flows**

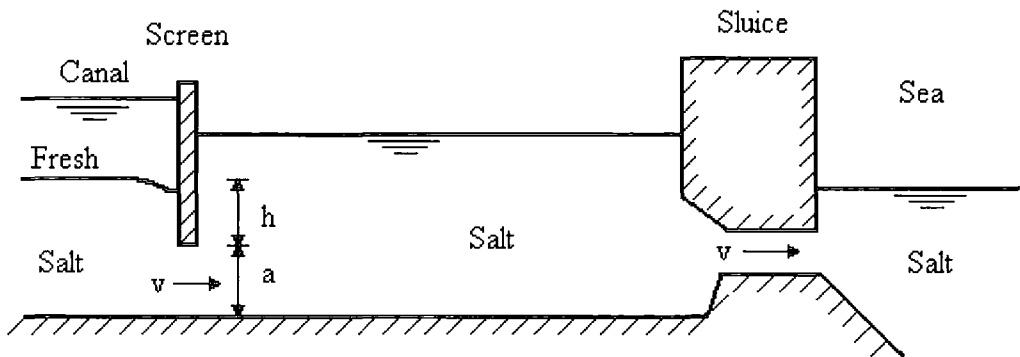
Figure 3-1 Sluice with screen for desalting (Schijf and Schönfeld, 1953)

It was suggested that the lower edge of the screen is situated below the freshwater-saltwater interface (FSI) to confine the opening ( $a$ -Figure 3-1) for the deep saline flow which results in increased velocities ( $v$ -Figure 3-1) and thus in higher expulsion rates. The authors already anticipated the sensitive task of regulating the flow velocity below a double critical value ( $v_{cc}$ ) to avoid freshwater expulsion through depression of the FSI surface ( $h$ -Figure 3-1) and to prevent interfacial mixing.

An alternative approach for managing marine water propagation within impoundments is the installation of screens or baffles. The idea was first outlined by Schijf and Schönfeld (1953) who suggested a fixed screen upstream of partial exclusion barrages to utilize the limited amounts of freshwater more effectively during sluiced flushing of saline water (Figure 3-1).

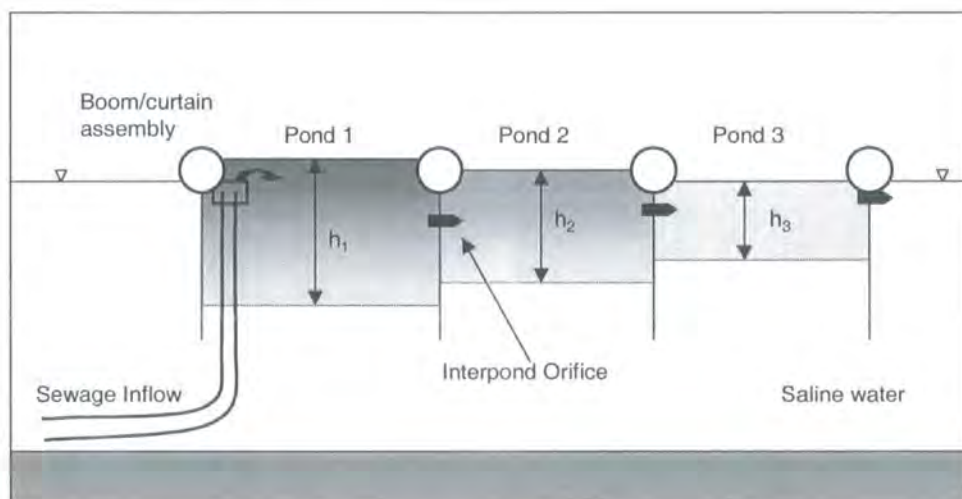
Figure 3-2 Schematic MBWSP concept with interpond orifices (after Burrows et al., 2001)

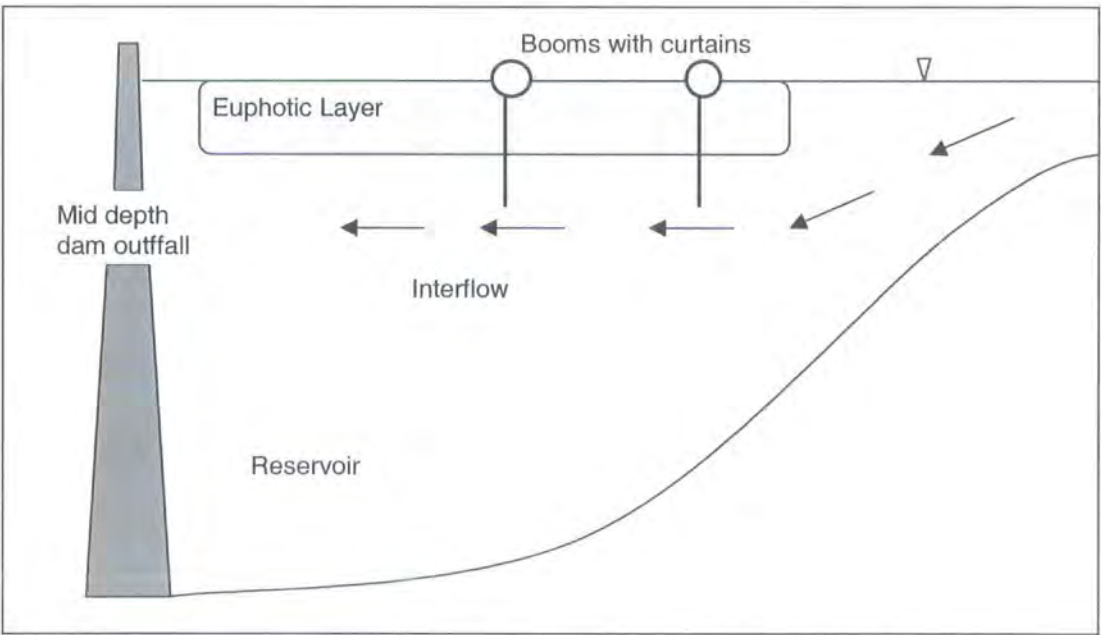
The flow diverting function of vertical curtains installed at the inlet of an eutrophic reservoir was investigated by Onishi et al. (2000). The curtains created an underflow (interflow-Figure 3-3) of nutrient rich waters passing the euphotic epilimnetic layer, thus, reducing the amount of algal bloom in the reservoir. Creation of an interflow was assisted by the plunging of low temperature (high density) inflows and mid-level withdrawal at the dam.

Figure 3-3 Eutrophic reservoir with curtains (after Onishi et al. 2000)
